<b>AT602167MQ</b> - MUON BARREL CHAMBERS DETAILED, SECTOR 15	<b>NTB_0003</b> - TB WARM STRUCTURE - SIMPLIFIED 3-D OBJECT	Clearance	22.5 mm			Warning
			$\Delta X \approx 0$	$\Delta Y \approx -22.5$	$\Delta Z \approx 0$

AT602167MQ - MUON BARREL  
CHAMBERS DETAILED, SECTOR  
15

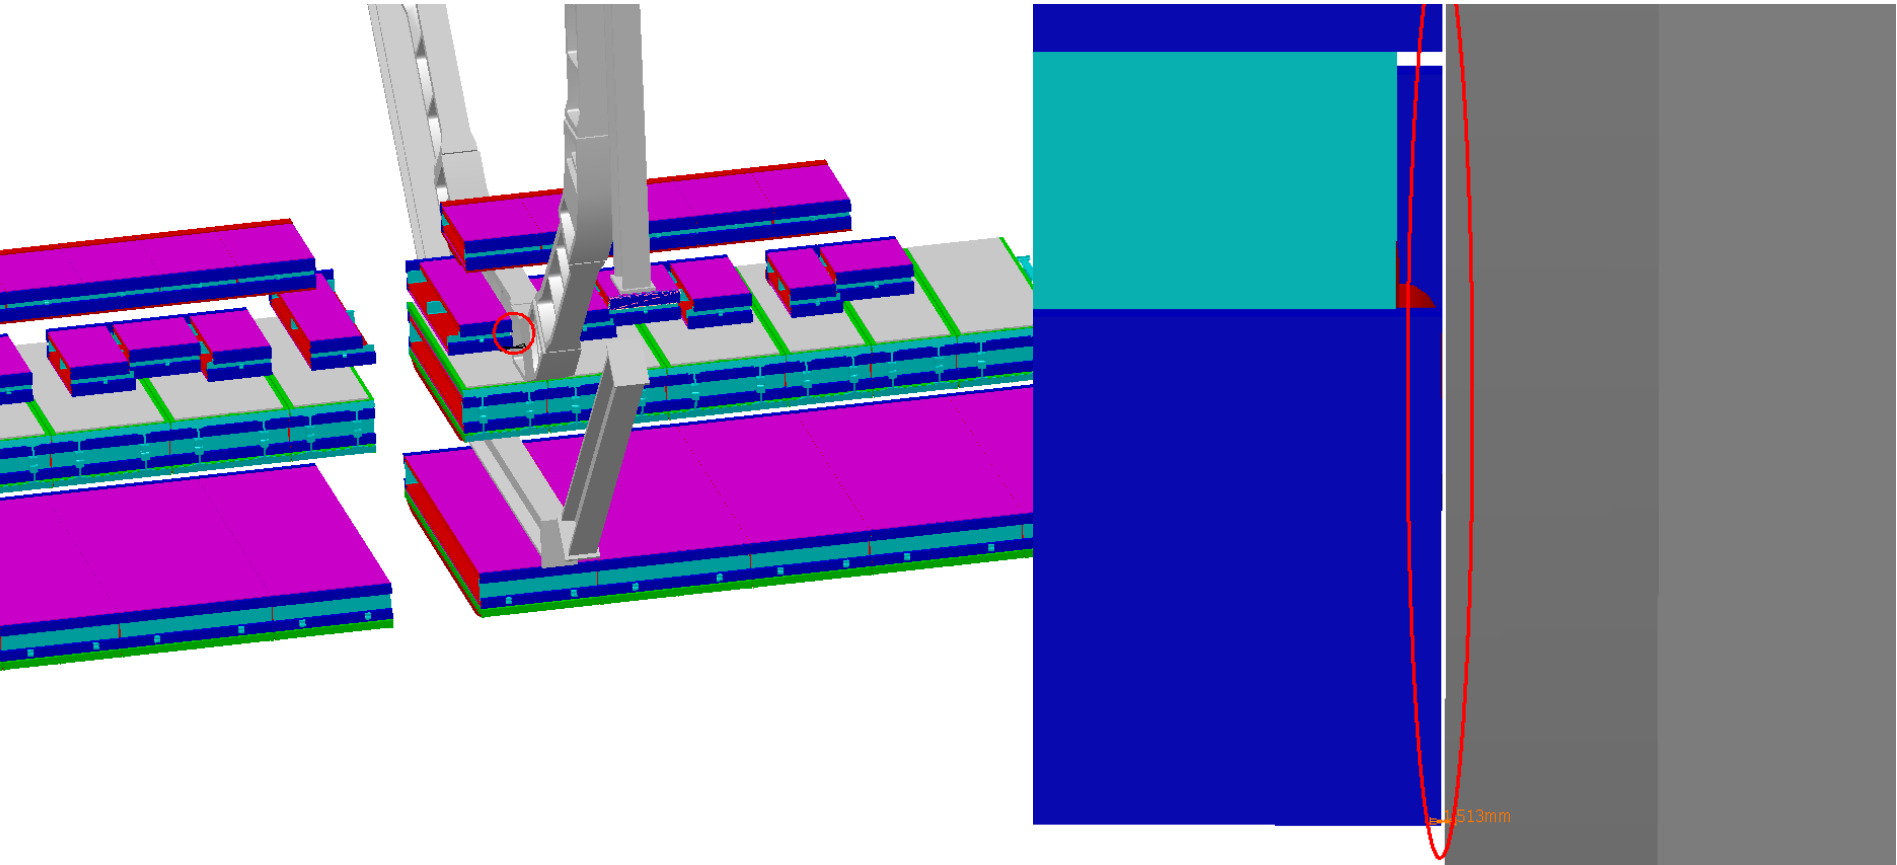
SIDE C  
Sector 15

AT602167MQ - MUON BARREL CHAMBERS DETAILED, SECTOR 15	NTB_0005 - TB WARM STRUCTURE - RING OF THE VOUSOIRS, STRUTS	Clearance	1.5 mm			Warning
			$\Delta X \approx 0$	$\Delta Y \approx 1.5$	$\Delta Z \approx 0$

Tatiana: Check with VTB

Lasha: I have checked with VTB, cutout exists. Clearance is 27mm.

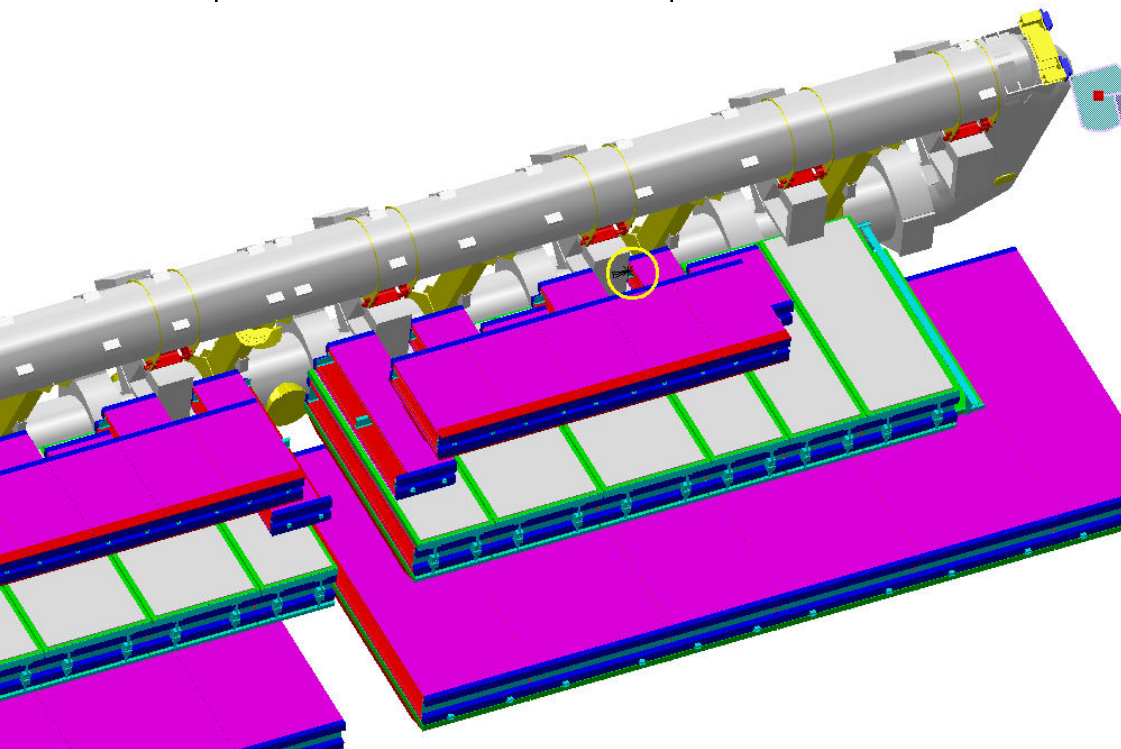
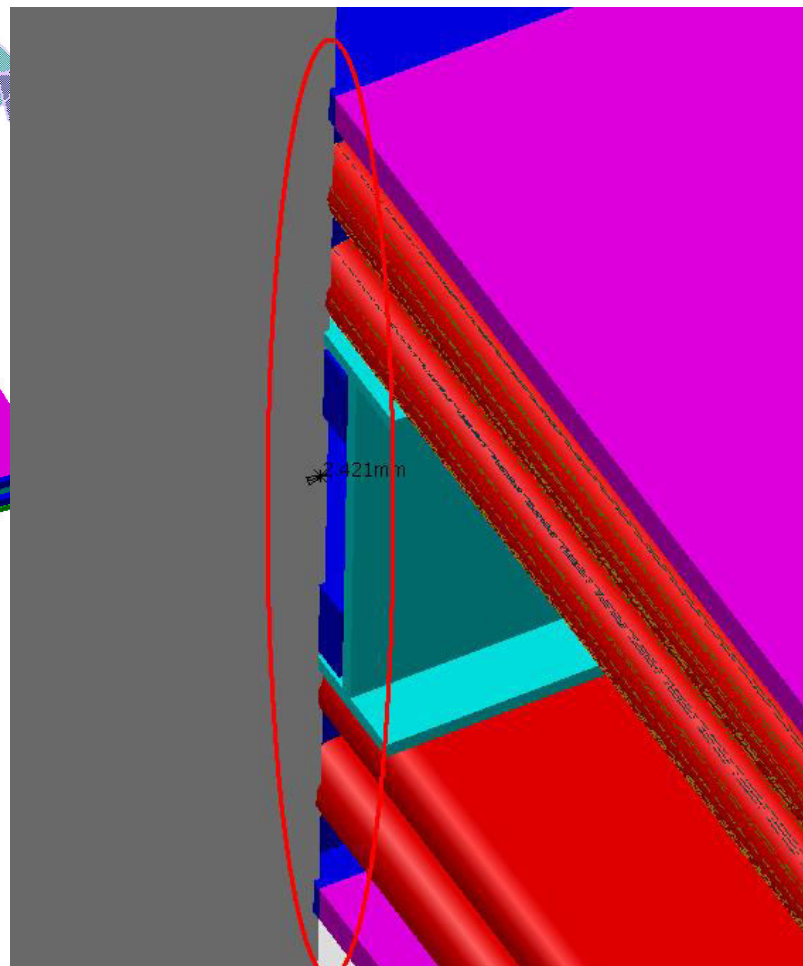
Sector 15

NTB\_0007 - TB FEET COIL - SECTOR 14

Clash

-2.4 mm

Clash value: ~ 2.4 mm

The identical clash exists on the opposite side

Tatiana: Check with VTB

Lasha: I have checked with VTB, cutout exists and there is no clash, however clearance is 22mm.
