Clash Publish

AT782484MQ - CABLE TRAYS
IN FEET C1-B-A1

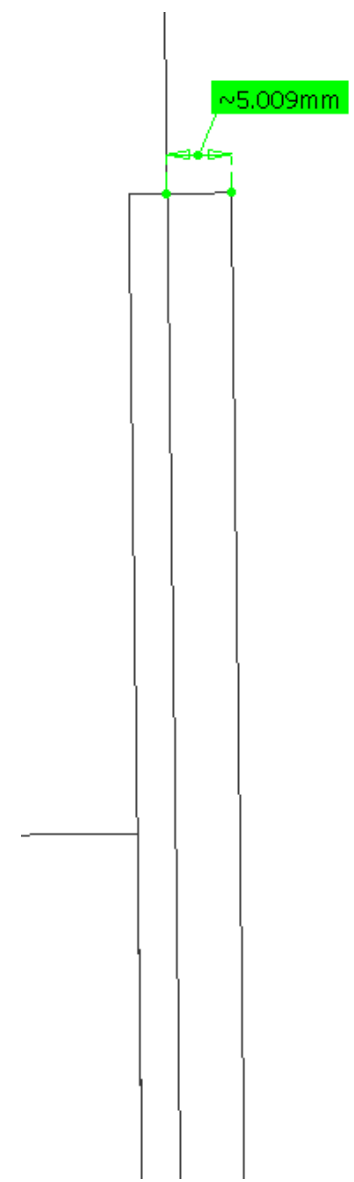
AT782484MQ - CABLE TRAYS IN FEET C1-B-A1	ATCVHB_0002 M - STANDARD PAIR OF FEET A1 (C1) - DETAILED MODEL FOR STANDARDS	Clash	-4.9 mm	Not inspected
---	---	-------	---------	---------------

Clash value: ~ 4.9 mm

SIDE C

Sectors 12, 14

The identical clash exists on the opposite side
